Failure modes and reinforcement techniques for timber beams – State of the art

Steffen Franke^{a,*}, Bettina Franke^a, Annette M. Harte^b

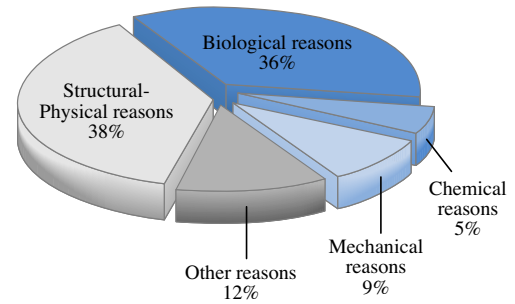
Fig. 1. Reasons for damages, [1,2].

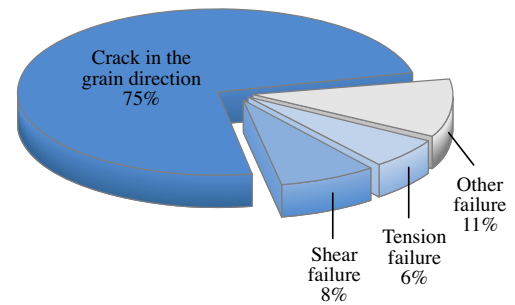
Fig. 2. Types of failure, [1,2].

The most common type of failure, Fig. 2, was observed as the appearance of cracks in grain direction. The variation of the surrounding climate at a timber beam changes the moisture content and lead to shrinkage or swelling of the cross section. Non uniform distributions of the moisture content over the cross section and/or restraint deformations lead to internal stresses and, if the material strength is exceeded, to cracks in the cross section which can significantly reduce the capacity, Figs. 3 and 4. For the determination of the influence of cracks in timber beams on the residual load carrying capacity or stiffness no comprehensive methods are known. Methods and guidelines for this evaluation are currently under development at the Bern University of Applied Sciences.

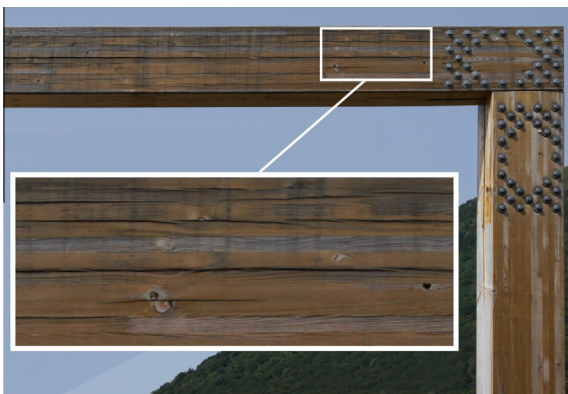
Fig. 4. Cracks in grain direction at a glulam member.

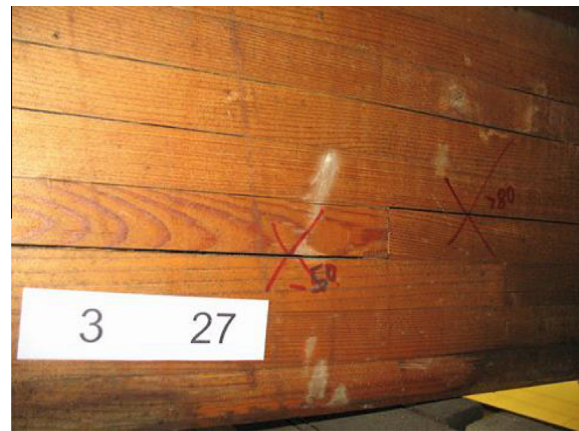
Fig. 5. Delamination at a glulam member.

Note: Failure under tension stress perpendicular to the grain in glulam members has to be distinguished from delamination failure within the glue lines as shown in Fig. 5. Special techniques can be used for the classification of delaminations as shown in [3].

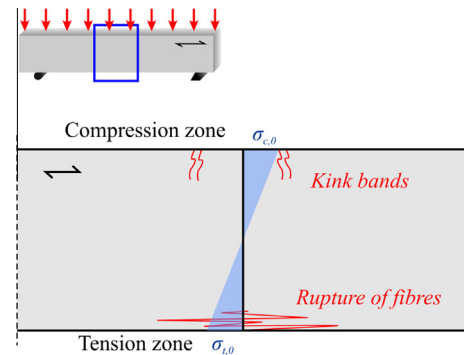
Fig. 6. Principal sketch for bending failure.

Bending results in longitudinal tension and compression stresses distributed over the depth of the cross section. The tension stress leads to a brittle failure due to the rupture of the wood fibres, as shown in Fig. 6. Longitudinal compression stress results in elastic and plastic deformations which can be described as ductile and leads to the so-called kink bands.

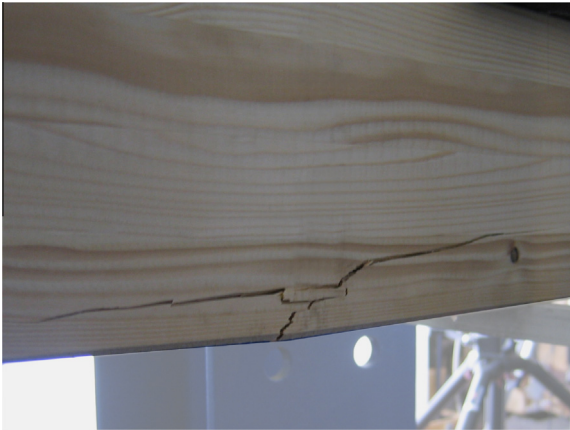
Fig. 7. Tension failure under bending.

Due to natural defects, such as knots, the tension strength can be reduced compared to compression strength. Therefore, bending failure is mainly described by brittle failure of timber beams within the tension zone, as shown in Fig. 7. Bending failure is classified as critical and can lead to a single failure of the structural element or the complete construction.

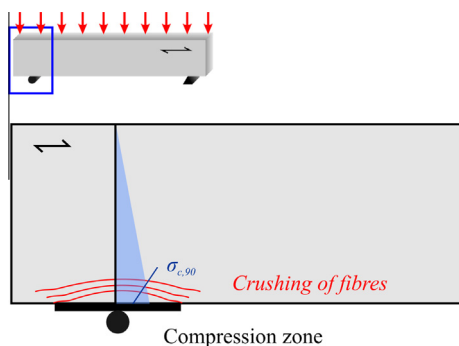
Fig. 8. Principal sketch for compression failure at support.

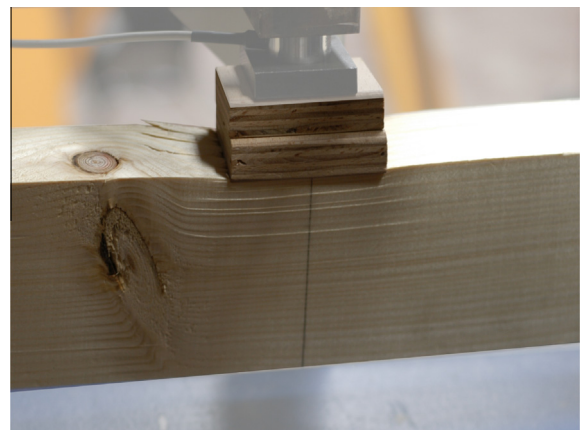
Fig. 9. Compression failure at loading point.

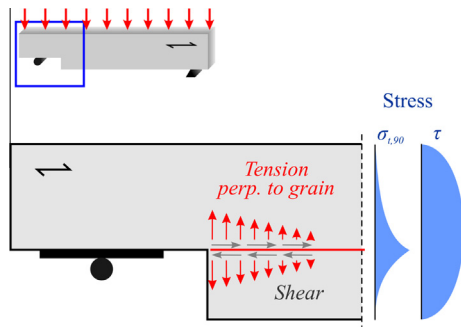
Fig. 10. Principal sketch for tension failure perpendicular to the grain at a notch.

Tension stress has to be considered parallel to the grain and perpendicular to the grain directions. When the tensile capacity of the timber is exceeded, brittle failure occurs. Examples of tensile failure parallel to the grain and perpendicular to the grain are shown in Figs. 10–12. However, due to the low tension strength perpendicular to the grain of wood, which is almost zero due to natural defects, failure under tension stress perpendicular to the grain occurs more often. Therefore, wood products are mostly optimised to increase the tension strength perpendicular to the grain. However tension stresses perpendicular to grain has carefully to be considered in the design. Tension stress perpendicular to the grain occurs in curved, tapered and end-notched glulam members as

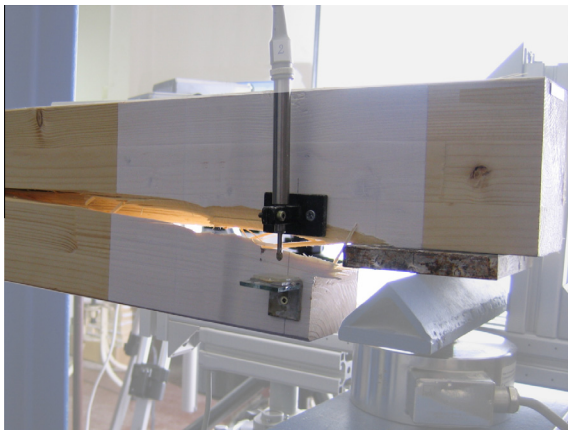
Fig. 11. Tension failure perpendicular to the grain at a notch.

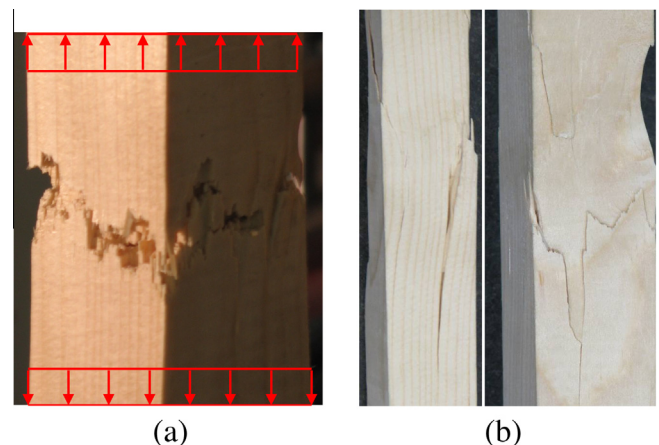
Fig. 12. Tension failure parallel to the grain of experimental tension tests: (a) short-fibred, (b) long-fibred, [4].

For the case of notched end beams, the stress concentration at the corner of the notch leads to crack initiation and rapid crack propagation results in a sudden brittle failure of the beam as shown in Fig. 12. The high tensile stresses perpendicular to the grain are accompanied by high shear stresses. Different reinforcement methods are illustrated in Fig. 24. The reinforcement can be deployed perpendicular to or at 45° to the beam axis. Due to the presence of high shear stresses, the performance of notched beams reinforced at 45° is superior. This has been validated by a number of experimental investigations [39–42]. Reinforced

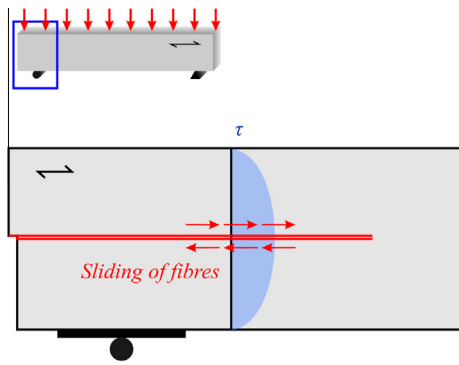
Fig. 13. Principal sketch for shear failure.

In most cases, bending stress and deflection limits govern the design of the members. But for short beams, tapered beams or special loading situations the shear stress can be more important. In general for beams, the shear stress reaches the maximum value close to the supports (Fig. 13). Additionally, end-notched beams and beams with holes can lead to shear stress concentrations, [5,6]. Failure due to shear stress is characterised by a sliding of the fibres and thus cracking parallel to the grain and is considered as a brittle failure. The cracks are mainly closed and therefore hard to detect if they are not at the end of the beam, as shown in Fig. 14.

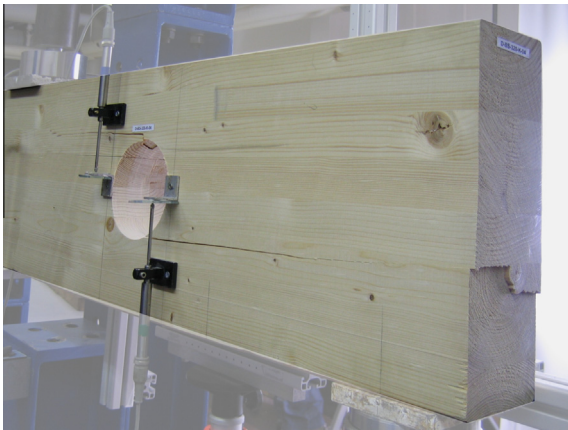
Fig. 14. Shear failure at holes.

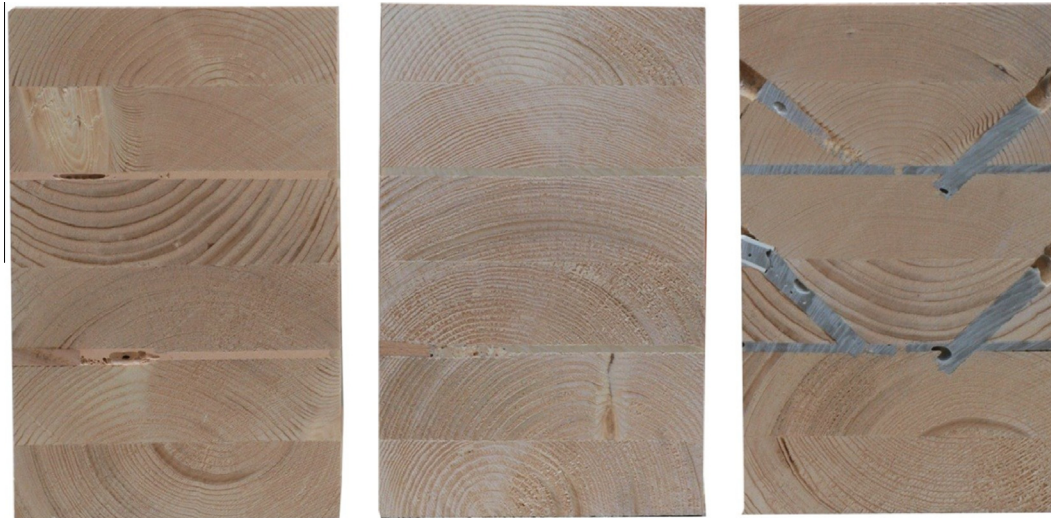
Fig. 16. Result of different repair methods (pouring and injection) for different adhesives, CSA Resin n'H Lungern (left), Purbond RE 3040, RE 3064 (middle), Jowat 692.30 (right), [13].

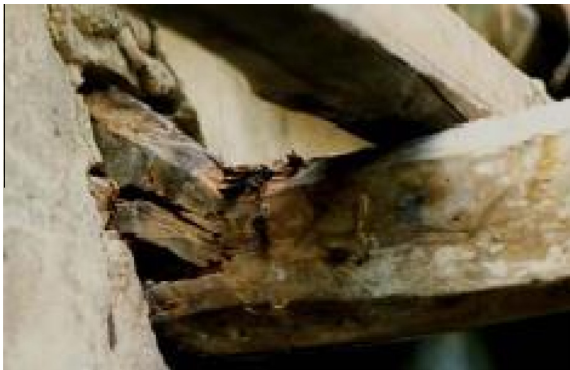
Fig. 17. Beam end decay [15].

Timber that has decayed due to fungal or insect attack is porous, fragile and has very poor strength properties [14]. This decay often occurs in localised parts of the beam, such as at the ends where the timber is in direct contact with a masonry supporting wall as seen in Fig. 17. In these cases, the condition of the rest of the beam is generally good. Other types of accidental damage, such as fire damage, may cause a reduction in the member cross-section resulting in inadequate strength and stiffness. Decayed and damaged materials/products should be removed and the member upgraded to restore the load-bearing capacity of the member.

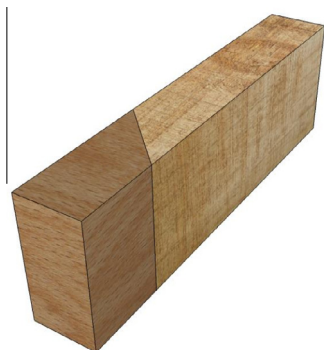
Fig. 18. Prosthesis with scarf connection.

Repair methods include replacing the damaged section with a timber or engineered wood prosthesis connected to the original beam by means of a scarf joint with wooden pegs and/or adhesive (Fig. 18), by means of bonded-in rods or plates (Fig. 19), [16].

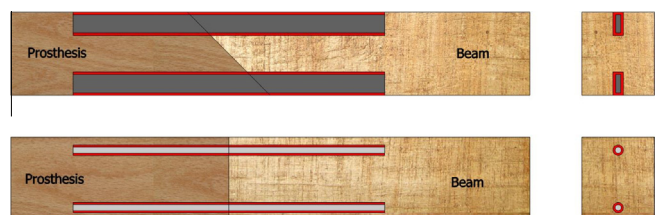
Fig. 19. Beam end repair using bonded in rods or plates.

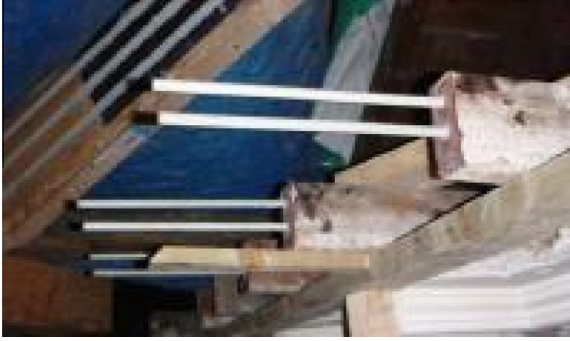
Fig. 20. GFRP rods inserted in ends of propped beams [18].

The span beams were repaired using an LVL prosthesis that was attached to the beams using six 20 mm diameter steel rods. The rods were bonded into holes drilled into the end grain of the beams and into matching side slots in the prosthesis, as shown in Fig. 29. Due to the lighter loading carried by the ceiling joists, it was sufficient to use a C24 softwood timber prosthesis that was bonded to the joists using two 12 mm GFRP rods. Fig. 20 shows the rods inserted in the joists before adding the prosthesis.

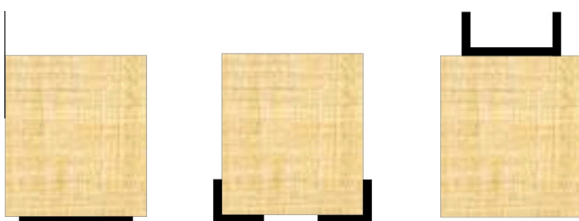
Fig. 21. External reinforcement arrangements.

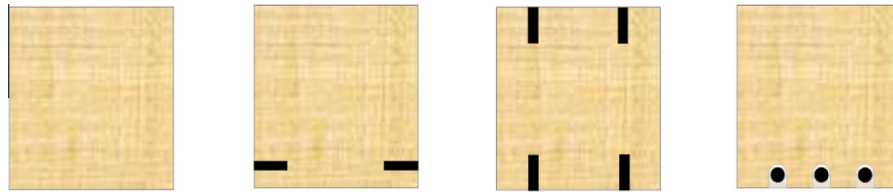
Fig. 22. Internal reinforcement arrangements.

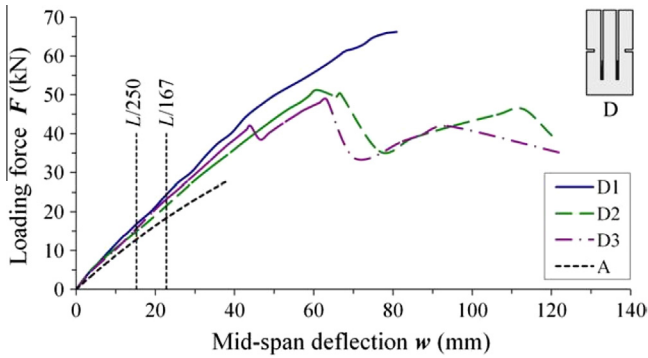
Fig. 23. Load–deflection response of unreinforced (A) and reinforced (D1, D2, D3) beams, [19].

As timber beams generally fail in tension in a brittle fashion, positioning of the reinforcement on the tensile face of the beams is very effective for increasing bending strength. With increasing percentage of tensile reinforcement, the neutral axis of the beam moves towards the bottom of the beam. As a result the compressive strain in the timber increases relative to the tensile strain and compressive yielding may occur before the timber eventually fails in tension. The load–deflection response for a timber beam reinforced with carbon fibre reinforced polymer (CFRP) plates, which were inserted from the top, is shown in Fig. 23, [19]. The unreinforced beam A has a brittle response. For the reinforced beams, two of the beams display significant ductility in their response before failure.

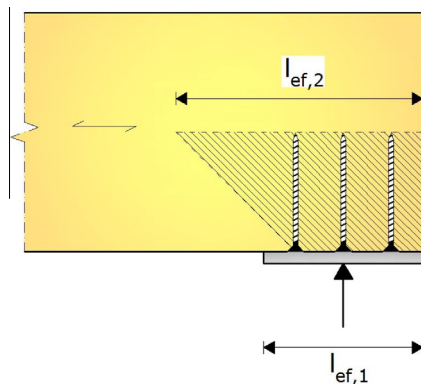
Fig. 27. Reinforcement for compression perpendicular to the grain.

where n is the number of screws, R_d is the lesser of the withdrawal capacity and the buckling capacity of the screw, $f_{c,90,d}$ is the design value of the compressive strength perpendicular to the grain [47], b is the beam width, $l_{ef,1}$ and $l_{ef,2}$ are the lengths as defined in Fig. 27, and $k_{c,90}$ is a load distribution coefficient in the range [1;1.75]

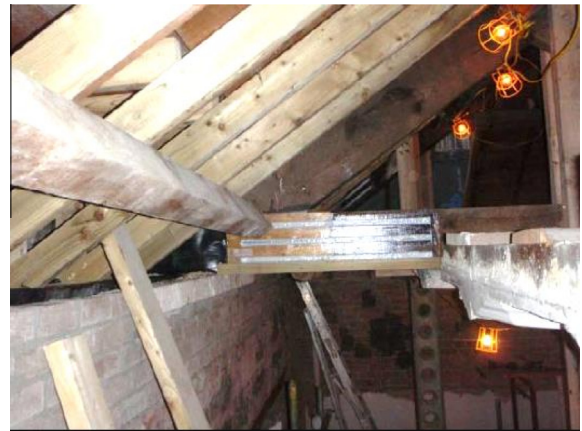
Fig. 29. Span beam repair [18].

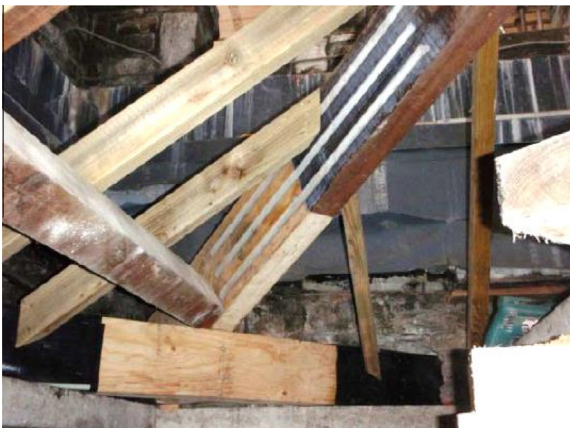
Fig. 28. Hip rafter repair [18].

An upgrade procedure was required that did not interfere with the ornate suspended ceiling. The solution that was adopted was to replace the decayed timber in-situ with a prosthesis made from laminated veneer lumber (LVL). Due to the restriction on access, the connection between the prosthesis and the hip rafters was effected using slots routed in the sides of the prosthesis and the rafter into which six 16 mm diameter high tensile steel rods were bonded using a two-part epoxy structural adhesive. Fig. 28 shows the prosthesis in place with the rods inserted in the slots prior to topping up with adhesive.

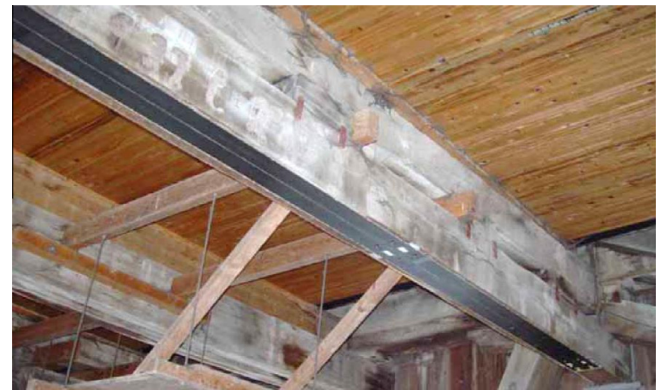
Fig. 30. Long-term monitoring of Sins Bridge, [57].

The cross-beams comprised two solid oak beams placed one on top of the other. The 1 mm thick CFRP laminates were bonded to the top and bottom surfaces using epoxy resin. Two types of CFRP were used: One was a high modulus material ($E = 305$ GPa, tensile strength = 2300 MPa) and the other was a high strength material ($E = 152$ GPa, tensile strength = 2600 MPa).

The reinforced cross-beams and a number of unreinforced crossbeams were instrumented with electrical resistance strain gauges and Demec gauges in order to monitor their long-term performance (Fig. 30). The deflection of the reinforced cross-beams was 20–50% lower than the unreinforced beams. Fourteen years after the original installation, the performance of the reinforced beams continued to be satisfactory [56].
